D117-762-011
Job Sheet 167189-A

Part Name: Skidtube with Standard Wearplates Fits LH or RH

DART SERVICE INSTRUCTION

TO AMEND INSTALLATION INSTRUCTIONS IIN-D117-762 REV. E AND
INSTRUCTIONS FOR CONTINUED AIRWORTHINESS ICA-D117-762 REV. 4

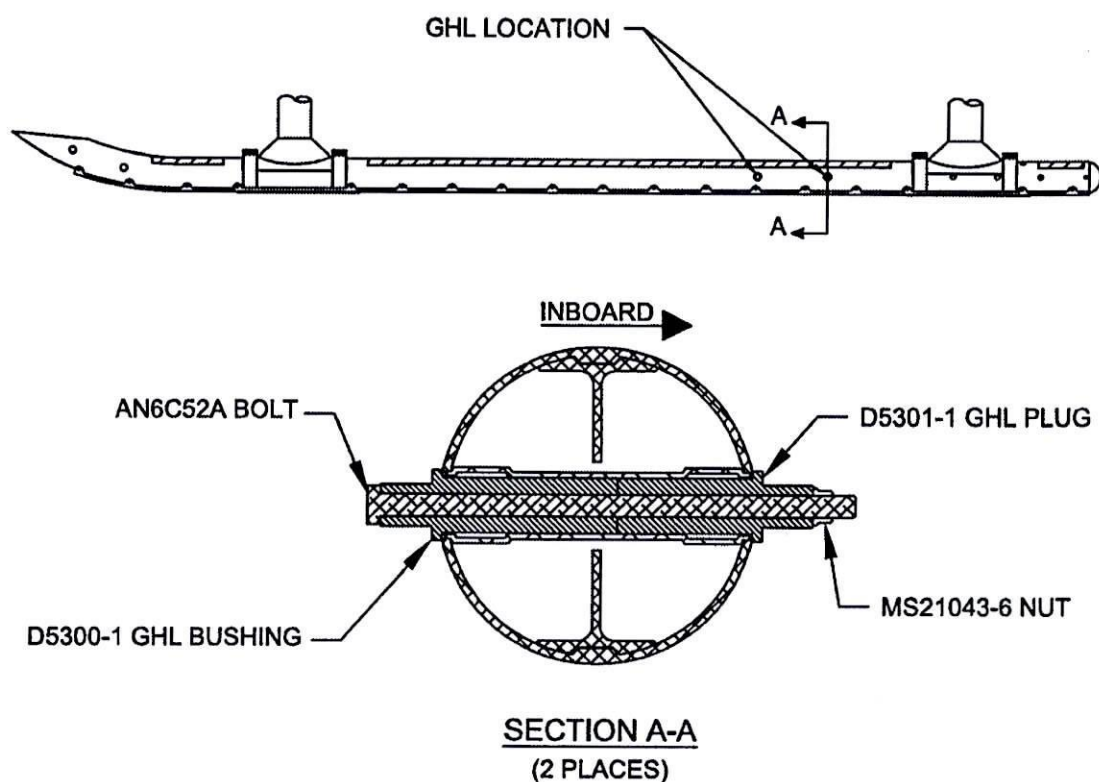
FIGURE 1 - GHL UPGRADE INSTALLATION

The purpose of this Dart Service Instruction (DSI) is to replace the ground handling lugs (D3864-1 Bushings, AN6C51A Bolts and MS21043-6 Nuts) on the D117-762-XXX Skid tubes with a structurally superior lug design (D5300-1 Bushings, D5301-1 Plugs, AN6C52A Bolts, MS21043-6 Nuts) as shown in Figure 1. The new hardware will be included in D117-762-011 @ CHG 004 and subsequent.

- 2.1 Loosely install (qty 2) D5300-1 GHL Bushing & (qty 2) D5301-1 GHL Plug wet with Proseal 890 or MIL-S-8802 Class B2 Sealant in location shown in Figure 1.
- 2.2 Install (qty 2) AN6C52A Bolts and (qty 2) MS21043-6 Nuts in accordance with Figure 1. Clean up squeezed out Proseal and apply fillet seal around D5300-1 & D5301-1.
- 2.3 Torque AN6C52A Bolts 160 - 190 in-lbs (18.1 - 21.5 N-m).
